Contract #: 04-0120F4Cty: SF/ALA Rte: 80 PM: 13.2/13.9File #: 69.28**WELDING INSPECTION REPORT****Resident Engineer:** Siegenthaler, Peter**Address:** 333 Burma Road**City:** Oakland, CA 94607**Report No:** WIR-017298**Date Inspected:** 30-Sep-2010**Project Name:** SAS Superstructure**OSM Arrival Time:** 1900**Prime Contractor:** American Bridge/Fluor Enterprises, a JV**OSM Departure Time:** 700**Contractor:** Zhenhua Port Machinery Company, Ltd (ZPMC), Changxing Island **Location:** Shanghai, China**CWI Name:** See Below**CWI Present:** Yes No**Inspected CWI report:** Yes No N/A**Rod Oven in Use:** Yes No N/A**Electrode to specification:** Yes No N/A**Weld Procedures Followed:** Yes No N/A**Qualified Welders:** Yes No N/A**Verified Joint Fit-up:** Yes No N/A**Approved Drawings:** Yes No N/A**Approved WPS:** Yes No N/A**Delayed / Cancelled:** Yes No N/A**Bridge No:** 34-0006**Component:** OBG**Summary of Items Observed:**

OBG Segment Trial Assembly

WELDING INSPECTION REPORT

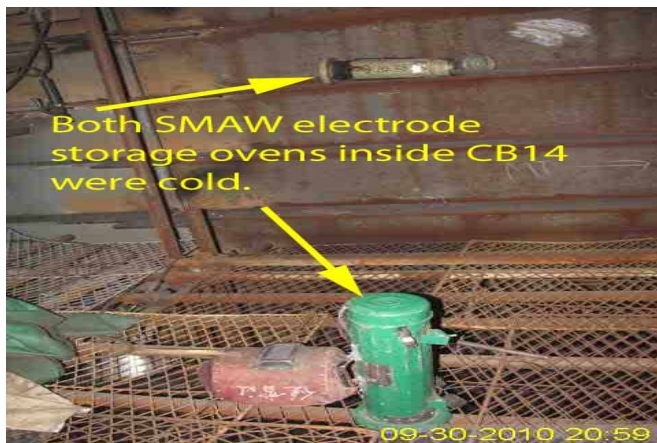
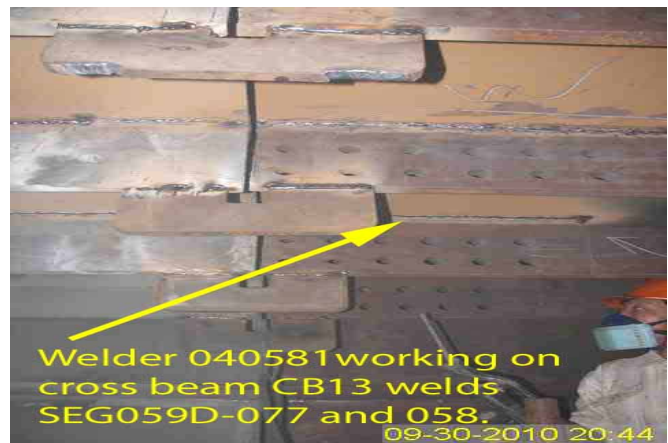
This QA Inspector observed no ZPMC welders working inside OBG cross beam 14. ZPMC CWI Mr. Liu Hua Jie informed this QA Inspector that welders stencil 037723 and 067609 had previously been performing welding inside OBG cross beam 14 and they had now left work. This QA Inspector observed three electrode storage ovens inside OBG cross beam 14. One of the ovens was not connected to any electrical power supply and it contained shielded metal arc welding electrodes that were cold to the touch, a second oven was not connected to a power supply and the electrodes were cool, but not hot, to the touch. The third oven was connected to an electrical power cable and it was warm to the touch. This QA Inspector showed CWI Mr. Liu Hua Jie each of the electrode ovens and he informed this QA Inspector that he will inform the ZPMC supervisor that these electrodes need to be removed. See the photograph below for additional information.
